**NEWARK BAY STUDY AREA  
PRP DATA EXTRACTION FORM**

# *Central Steel Drum Company, Inc. Newark, New Jersey Site*

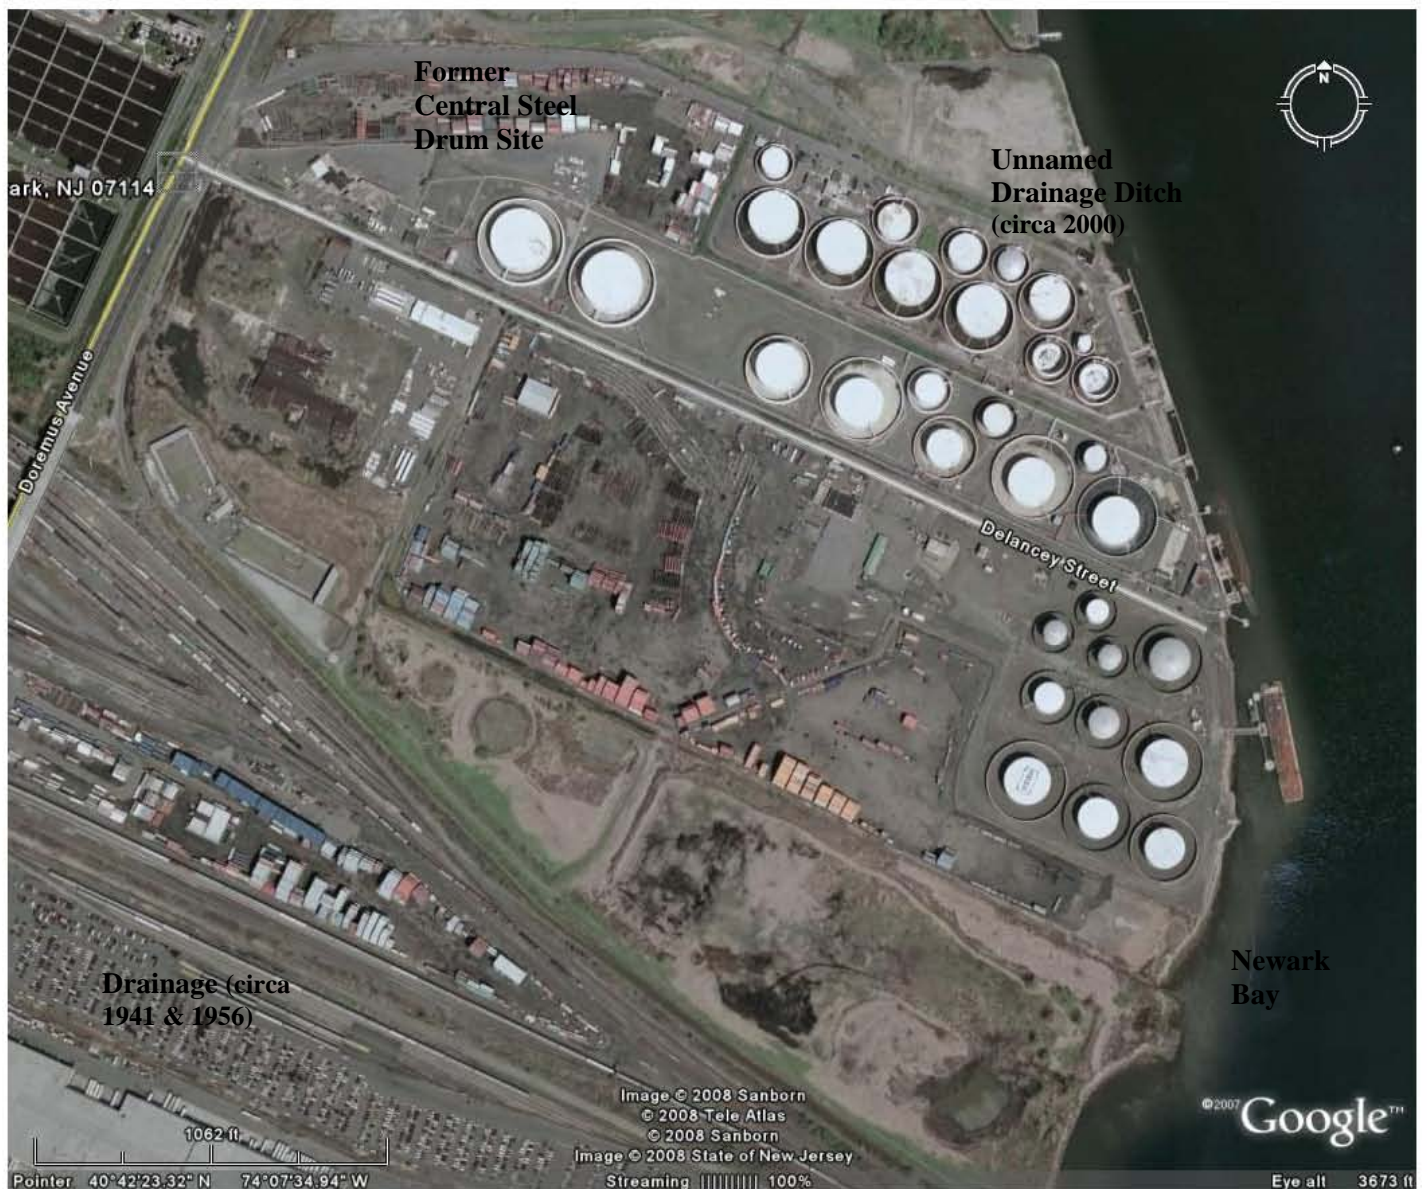
**Central Steel Drum Company, Inc.**  
704 Doremus Avenue  
Newark, Essex County, New Jersey

The location of the drainage ditch, as taken from NJDEP 2000 Orthophotographs, is depicted on the following aerial photograph. Historical drainage, as taken from 1941 and 1956 Essex County Mosquito Extermination Commission maps, is also shown on the aerial photograph. BBG000192, BBJ000001, BBJ000002

The approximate locations of the Site and drainage features are shown on the following annotated aerial photograph:

Aerial Photograph Copyright 2008  
Photo Source: Google Earth (Sanborn/Tele Atlas/State of NJ)

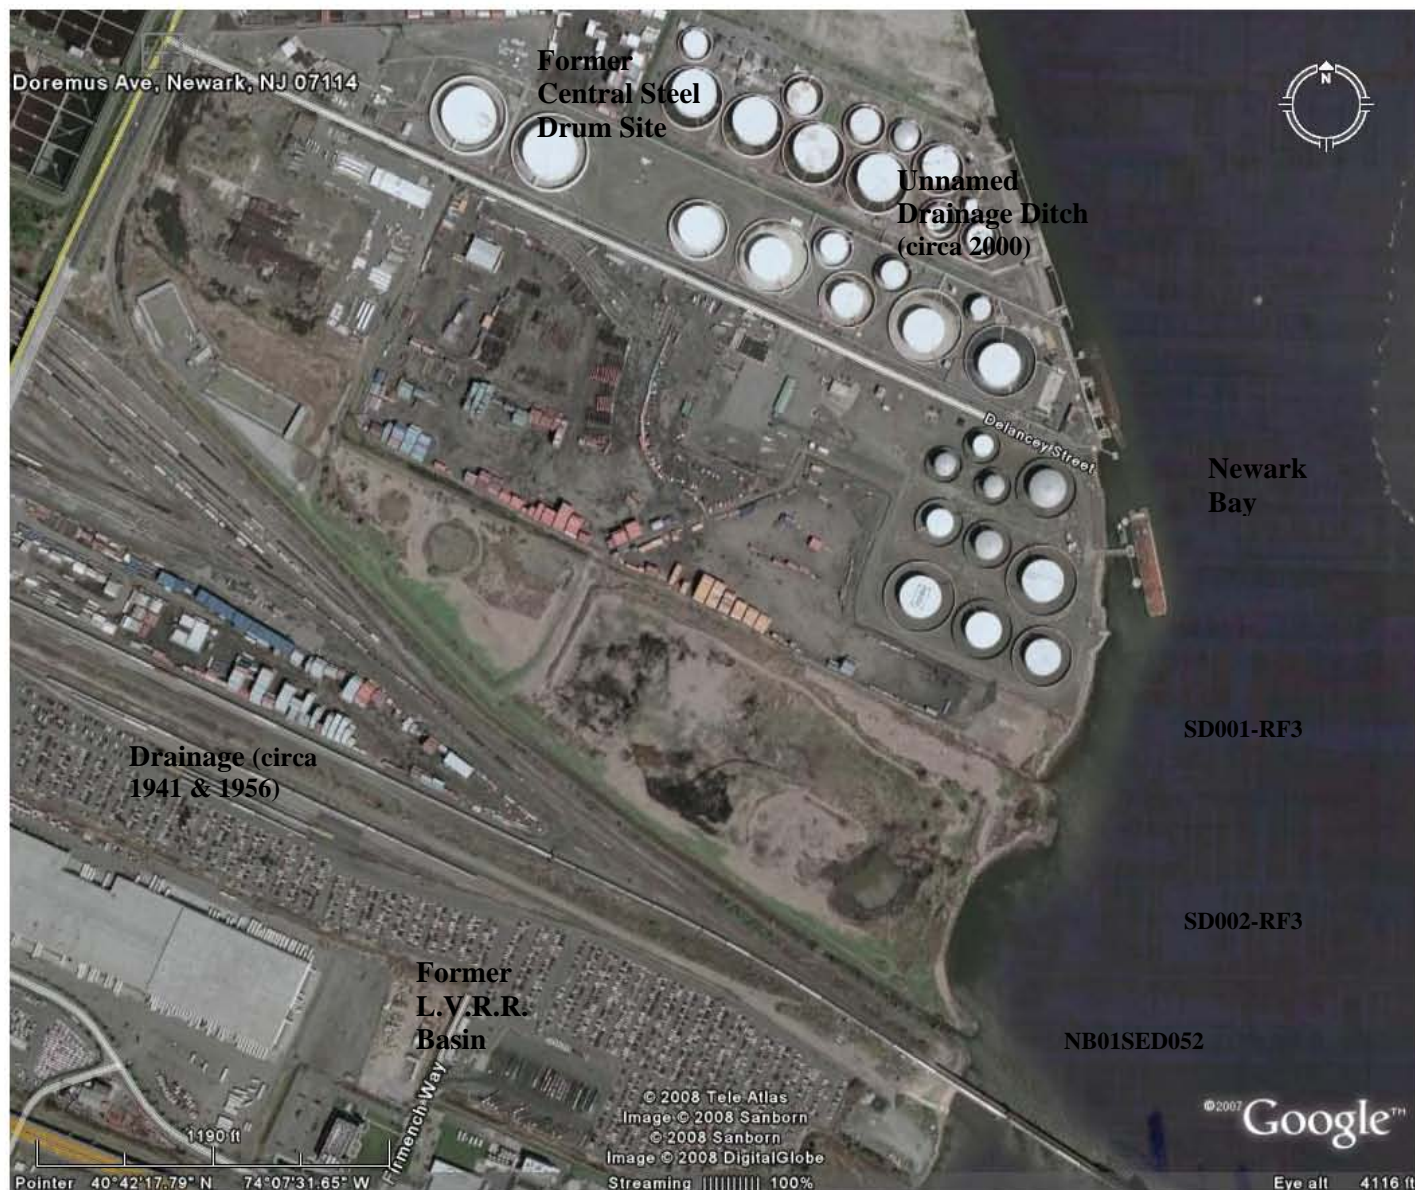
## Newark Bay Sediment Samples

Sediment sampling conducted in Newark Bay indicates contamination matching the hazardous substances reported to be on-Site. A review was conducted of the analytical results for three Newark Bay sediment samples, identified as SD001-RF3, SD002-FR3, and NB01SED052, located in the vicinity of the outfalls of ditches that drain the Site. The approximate locations of the Newark Bay sediment samples are identified on the following annotated aerial photograph:

Central Steel Drum Company, Inc.  
704 Doremus Avenue  
Newark, Essex County, New Jersey
